**From:** "Jan Noble" <JNoble@wollongong.nsw.gov.au>  
**Sent:** Thu, 16 May 2019 12:36:10 +1000  
**To:** "Lucy Wiewiora" <Lwiewiora@wollongong.nsw.gov.au>  
**Subject:** HPRM: FW: Helensburgh Community Centre - Water Ingress  
**Attachments:** Design Requisition Helensburgh CC.docm, observations & discussions HCC.DOCX, SN assessment May 2019.docx

## **Wollongong City Council-Helensburgh Community Centre.**

Assessment of subfloor area and general interior/exterior to the above multi- purpose facility. The area in question of the basketball and multi-purpose section encompasses an area of some 510 square metres. The hardwood timber floor, believed to be Ironbark or similar, is layed upon hardwood bearers/joists, Messmate or similar. This in turn is founded onto 350by 350mm brick piers. The sub-floor and foundation material is severely water charged most likely from a natural water spring occurring through the impervious sandstone layers typical of the area.

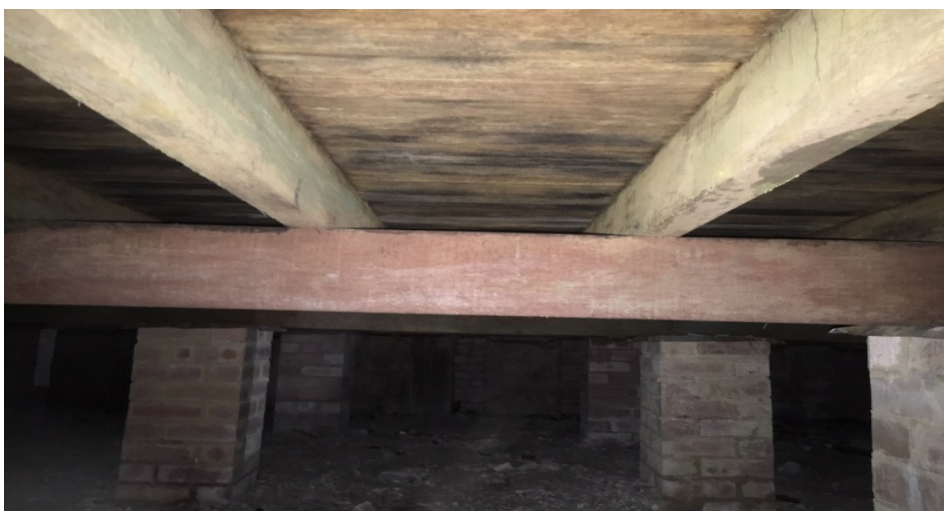
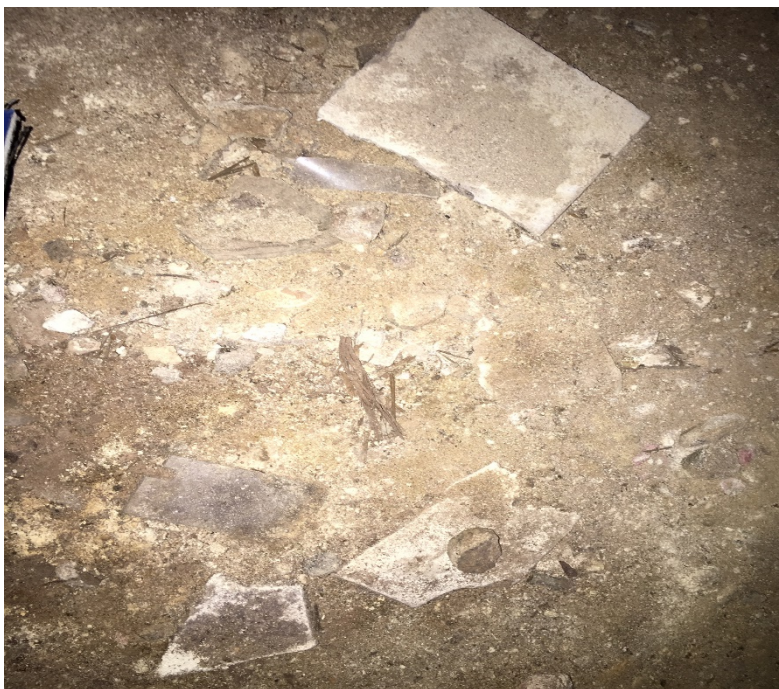
Whilst the timber floor is a durable species and is not suffering the effects of woodrot from below, the bearers and joists particularly towards the stage area, are in a state of deterioration. The remainder of the bearers and joists are still in a sound condition albeit with evidence of mould throughout, which will need to be addressed as a health hazard during take up, handling and disposal. Air quality in the sub-floor is generally very poor.

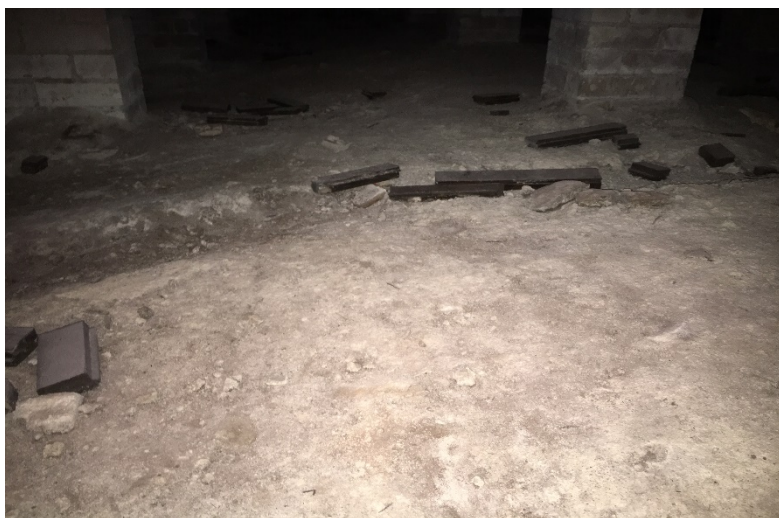
There is also evidence of Fibro fragments, such as broken up packing material strewn around the subfloor. Given the building was constructed in 1978, it would be almost certain this has Asbestos content in these pieces.

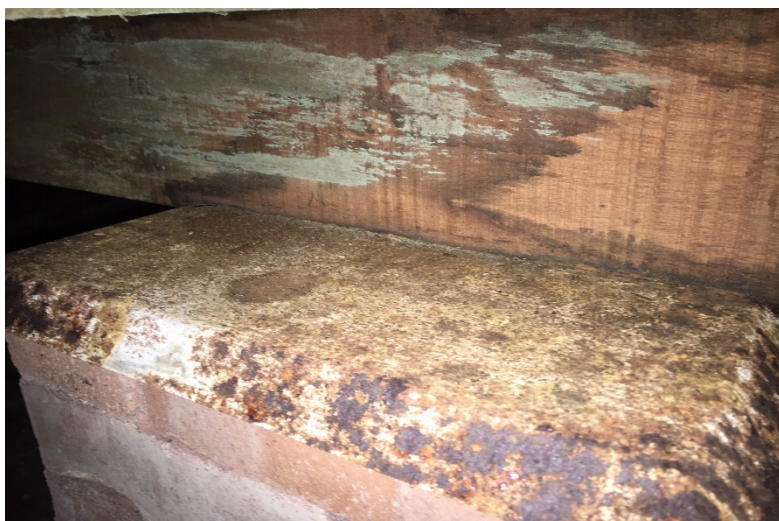
Also noted is a lot of timber flooring offcuts left on the ground and given the amount of moisture present on the ground, this could attract termites as a potential food source.

Ant cappings particularly nearer the direction of the stage are suffering corrosion and will need to be replaced.

Further evidence of mould is present on the timber bearers as shown here.

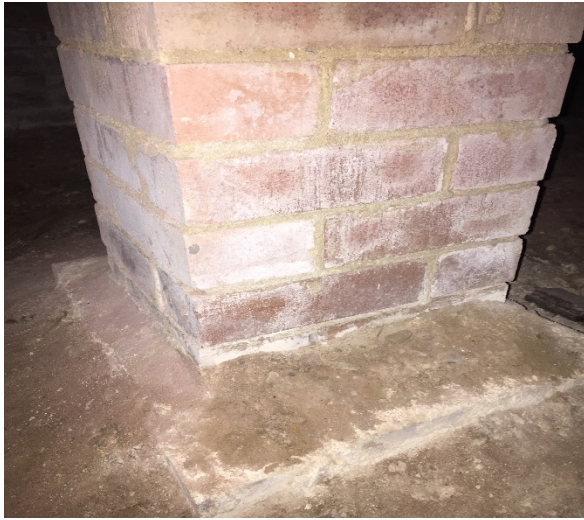
The brick piers in general still appear to be well founded and have not sunk or rotated over time.

On test, the mortar still is reasonably stiff and the bricks have not fretted away from the amount of moisture.

There is a white powdery coating on most piers indicating an efflorescence coming out.

Typical spacings of the piers are at 1.8 metre centres. The bearers are spaced centrally on

the piers and the joist centres are @ 450mm, which is within standard building code regulations of maximum spacings.

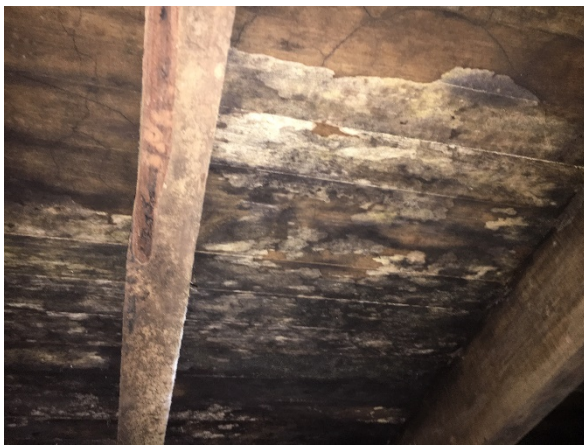
As mentioned previous, there is a significant amount of mould present that is detrimental to the health of people. Proper WHS handling methods will need to be adopted.

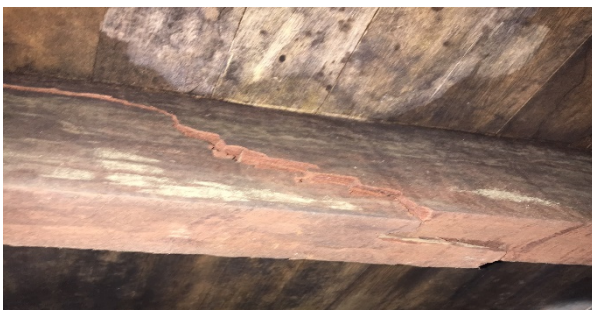
As can be seen in this picture, a floor joist has broken it's back due to the effects of wood rot. There is also the situation of the wiring, which needs to be made good during the replacement of the floor. It would be recommended to replace given that is coated in mould as well.

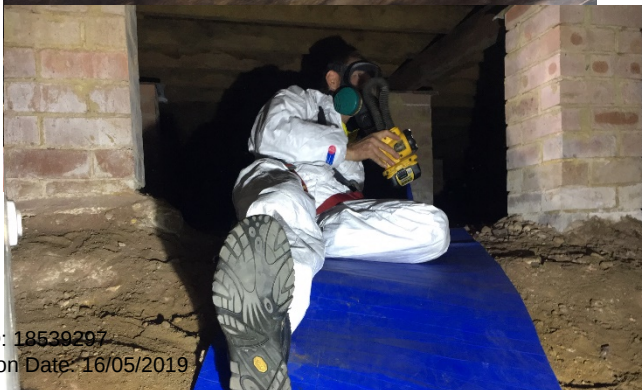
Numerous electronic moisture readings were taken of the below floor, including joists and bearers. On the day of testing being 29<sup>th</sup> April, 2019, an average reading

in numerous locations was in the vicinity of twenty three percent. Floorboards on the underside were indicating nineteen percent(approx. two percent can be added to the floorboard reading due to it's species). The ambient temperature was in the vicinity of approx 20deg and therefore based on this, the temperature compensation would be zero. Typically a moisture reading in a normal environment of most timbers would be expected to be in the ten-twelve percent range. Also noted is the fact that drying fans were activated for a minimum of four days prior. Weather patterns in the months' prior have not shown excessive rainfall for some time.

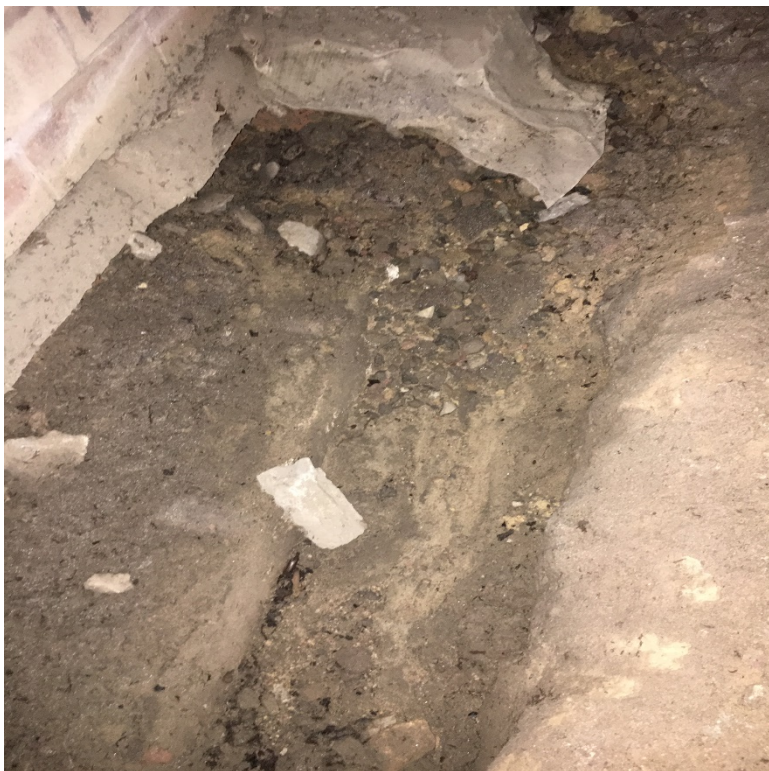
At left shows some scouring out of the wall adjoining the sub-floor and storage area below the stage. Still evident is a large amount of wet soil present.

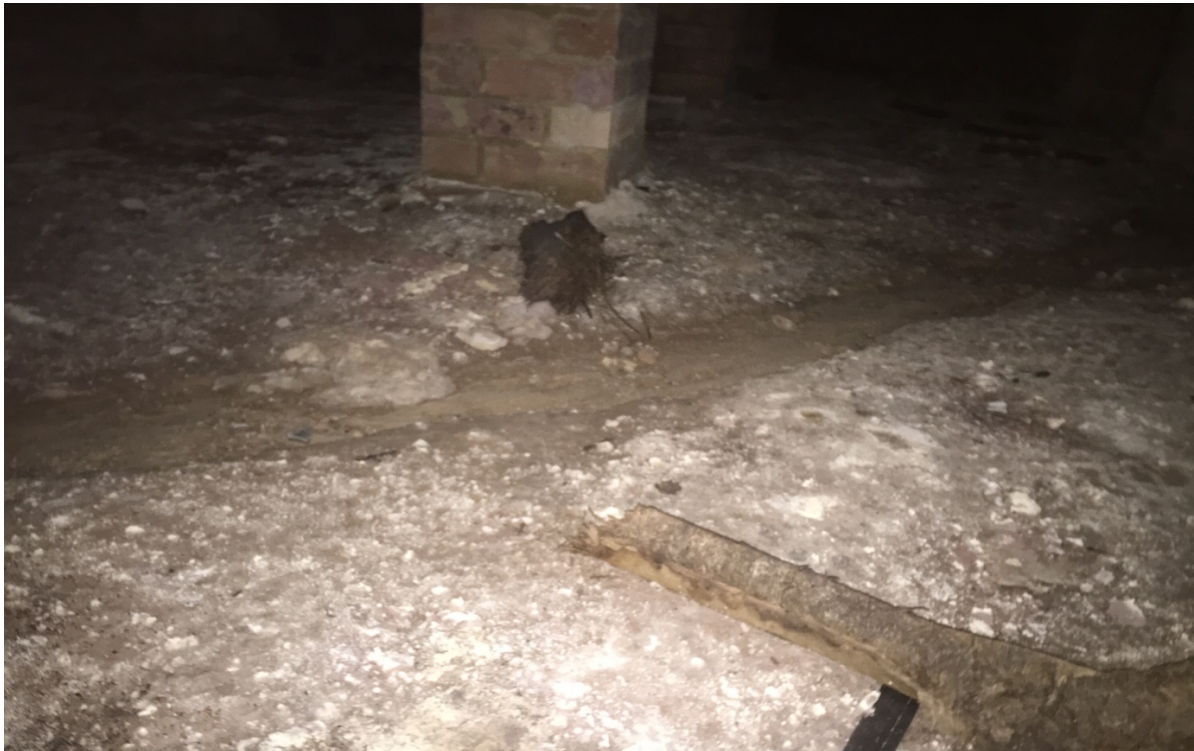
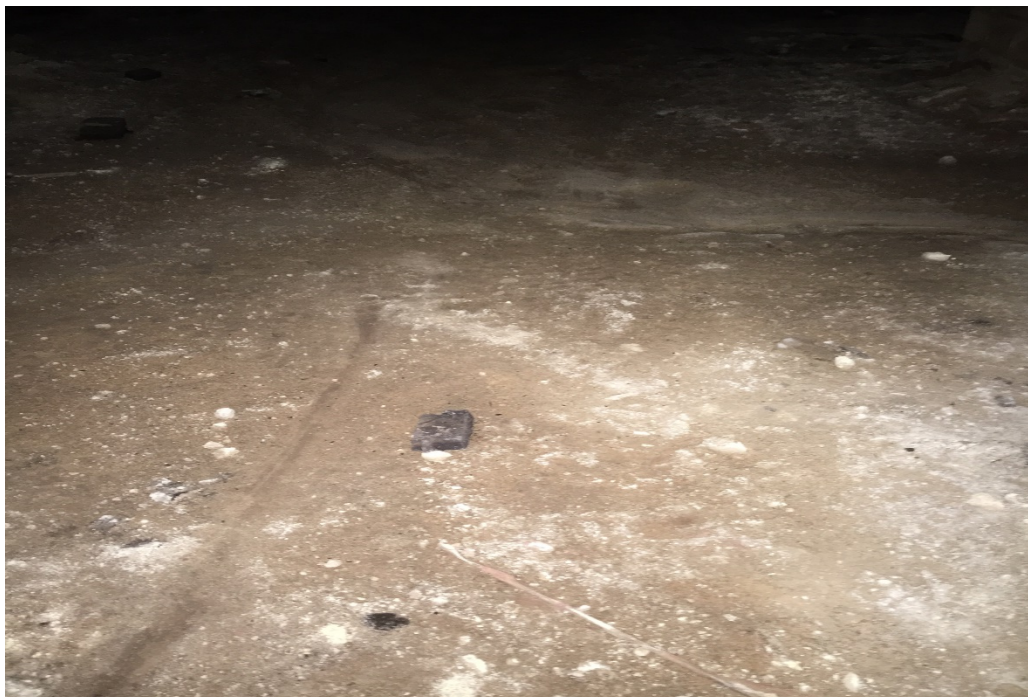
Running down the middle from the west is a distinct path where surface water tracks down and then diverts across towards the North East corner of the building.

There is no exit point for the excess water to escape and therefore 'pools' up in the swale at the lowest point.

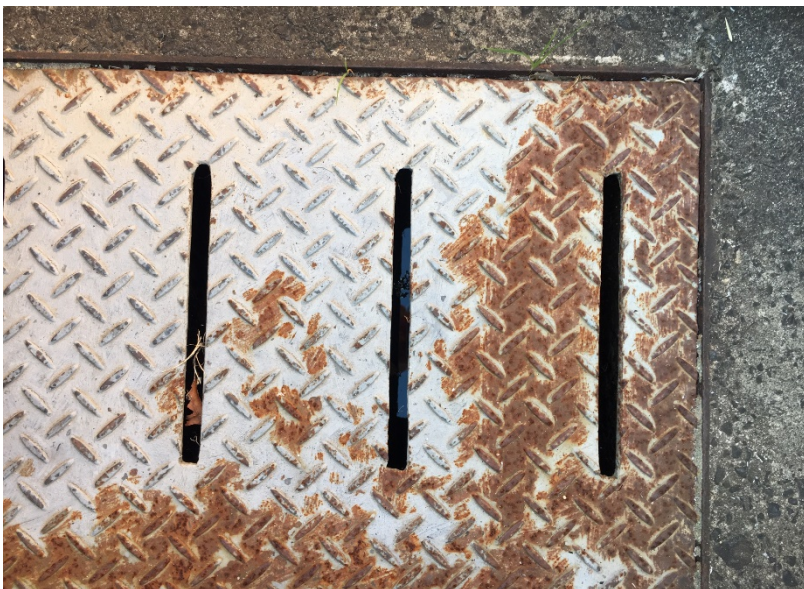
This drainage pit (west) was full of water on the day. A plumber should be engaged as part of the process to clear all drains and carry out a 'Dye Check' or similar to see if the ground water does in fact carry through the pipework where it is intended to terminate. This would determine if a stormwater pipe could be broken under the building or causing the water issue.

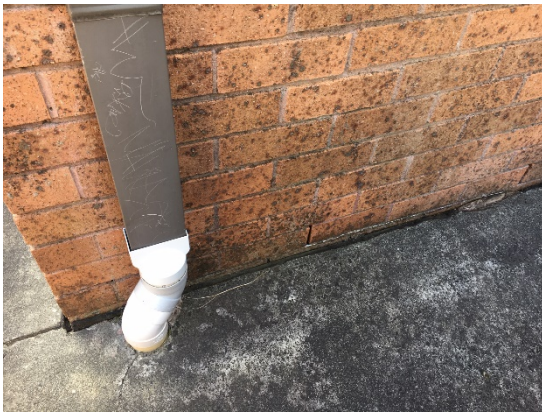
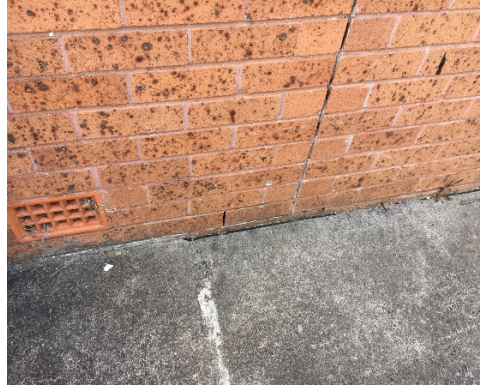
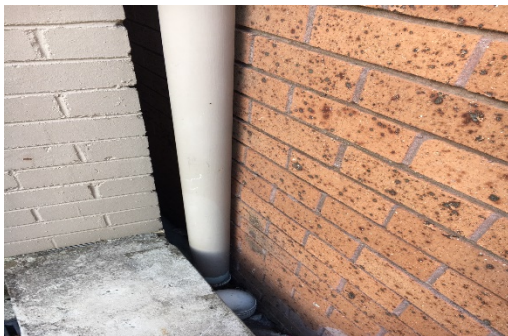
Raking out of the expansion joints of the junction to the walls/concrete pathway and then applying caulking with a polysulphide will assist in stopping surface water from getting into the building. It is also noted that a number of downpipes are not properly engaged to the stormwater socket.

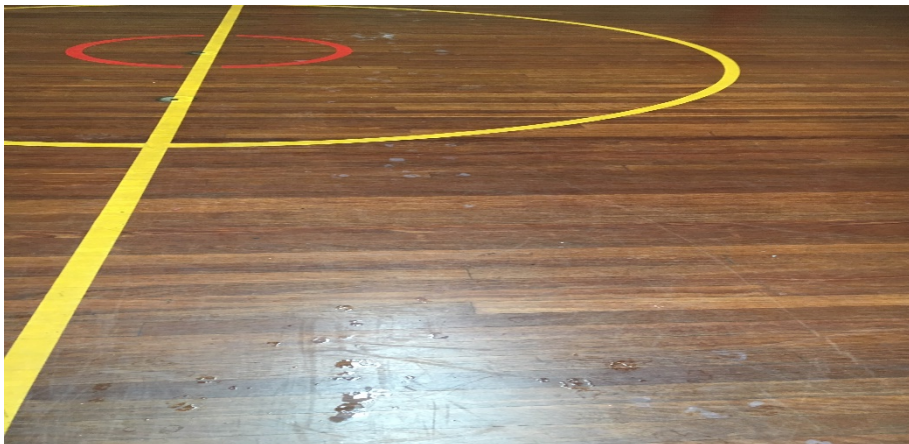
A reasonable quantity of water was noted on the floor immediately below each of the roof skylights. This indicates a high level of condensation within the building due to a general lack of airflow. Supply and installation of 'Hurricane' type roof ventilators of a large size, say 500-600mm throat diameter minimum will allow extraction of air. Multiple units can be installed near the ridgeline with a 'soaker' type flashing installed and

tucked under the ridge capping for weatherproofing.

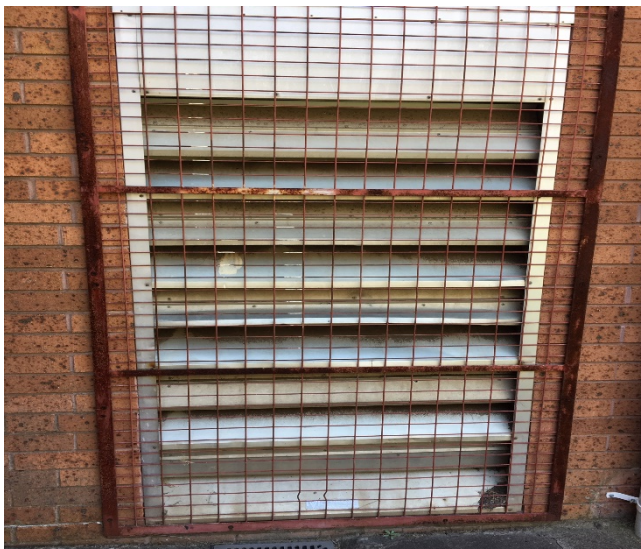
To further increase air movement throughout the interior of the building, the exterior intake air grilles should be re-established, as presently these are sealed off. This will allow more cross flow ventilation. Terracotta vent bricks on the exterior can be removed and replaced with larger vents with a mesh type exterior (commercially available). This will promote further airflow not necessarily in the sub floor but will enhance ventilation within the cavity brickwalls.
