Ref: KB  
Ext: 8106  
File No: GT19.271  
TR-671

**Re: HELENSBURGH COMMUNITY HALL  
GEOTECHNICAL INVESTIGATION  
INTERNAL REPORT ONLY**

GT19.271, Helensburgh Community Centre

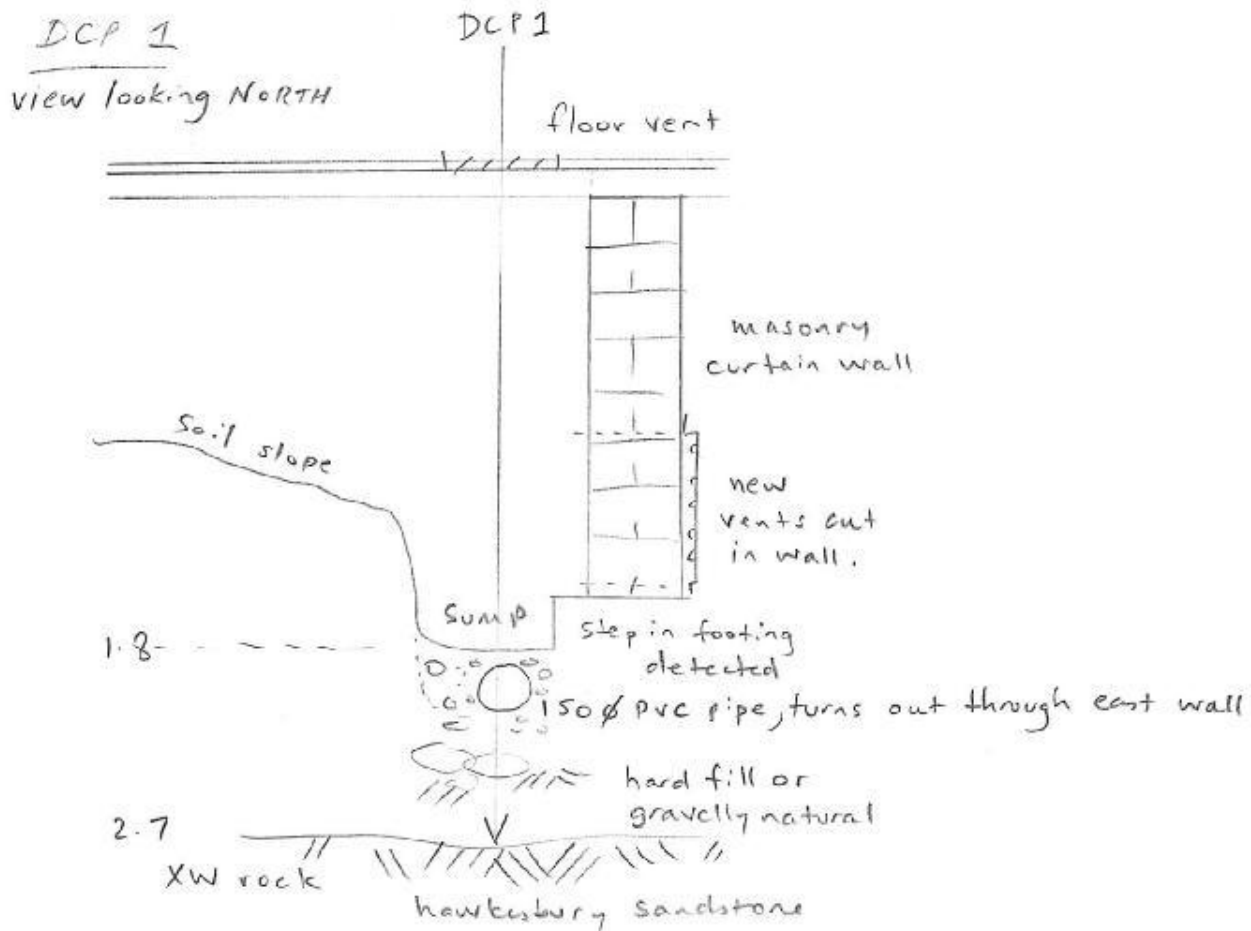
# CIT 19.271 HELENSBURGH COMMUNITY CENTRE

We observed an excavation behind the eastern curtain wall in the south corner consistent with the drawings showing a drainage sump at that location. We could not find the outlet, but did observe a 150mm diameter PVC pipe through the floor of the sump.

DCP testing in the sump showed that the floor of the sump is not founded on impervious material or rock and would be of little use in detaining free flowing surface water.

NOTE PVC pipe has no inlet for sump pit  
Sump pit outlet not found.

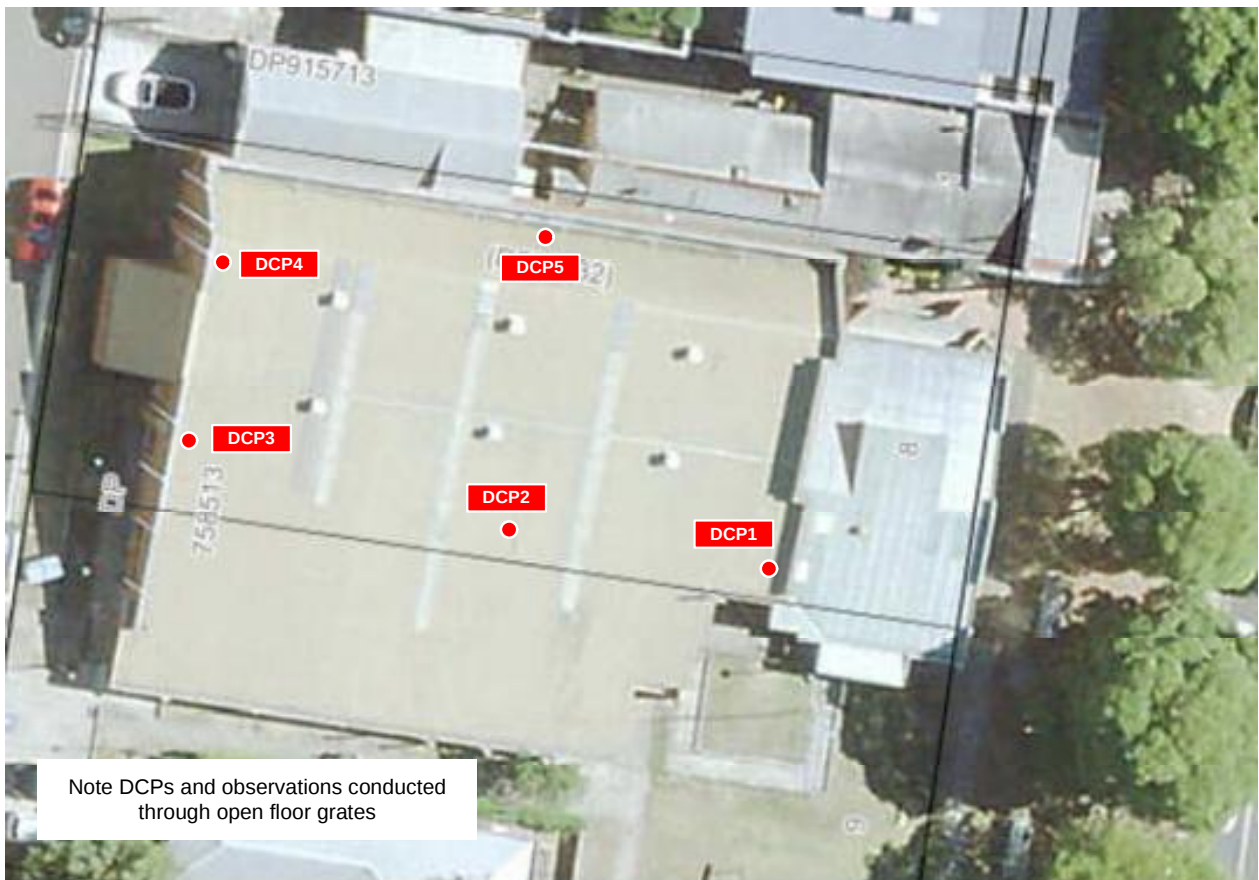
GT19.271 – D1  
Helensburgh Community Centre  
Test Location Drawing

DCP tests in the western half of the hall (DCPs 3, 4 and 5) show that hard refusal on rock occurred around 0.1 to 0.4m from the start of the test, indicating shallow rock generally. In the east of the site, the depth of overburden soils increased significantly to 0.9m (DCP 1).

These DCPs are consistent with our speculation that the western hall subfloor space was cut to rock, with the eastern half on the natural stripped surface, with a transition somewhere around the middle of the hall. It is also probable that, considering construction practices of the day, that the eastern curtain wall does not extend the full 0.9m to bedrock throughout.
