# MICROBIAL ASSESSMENT

## HELENSBURGH COMMUNITY CENTRE & YOUTH CENTRE

26 WALKER STREET  
HELENSBURGH NSW 2508

| Reference: | Revision: | Date of Report: | Prepared By: | Authorised By: |
|---|---|---|---|---|
| 20-13128-03-OH | Revision 0 | 17/12/2021 | Luke Parkins | Michael Fernandez |

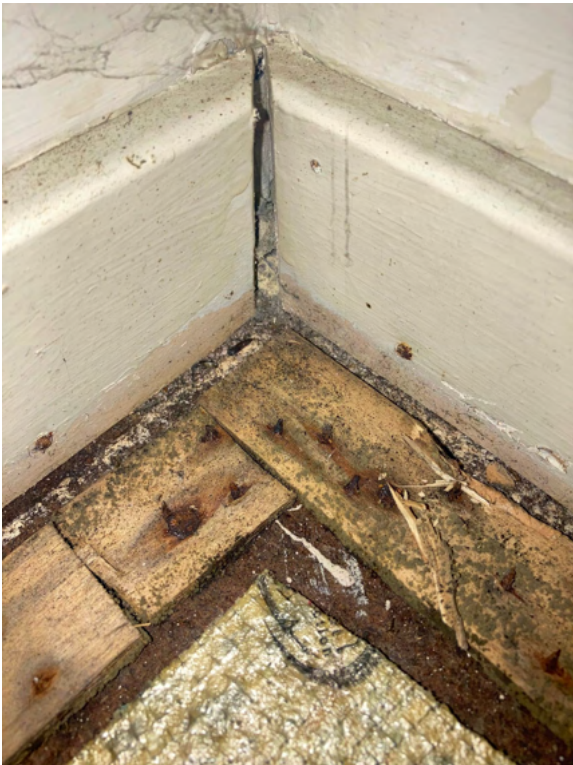
| Sample No. | Location | Bacteria Count (CFU/swab) | Mould Count (CFU/swab) | Yeast Count (CFU/swab) |
|---|---|---|---|---|
| 20-13128/S1 | Youth Centre, internal, south-western 'Office', south-western corner (underneath carpet on timber strips) | <10 | >3000 est. | 'Unable to report yeast due to overgrown mould' |

| Photo | Location |
|---|---|
| | <p>Representative photograph of the timber strips underneath the south-western corner of the carpet of the south-western 'Office', at the time of the inspection</p> |

- It is recommended that the carpet within the south-western 'Office' is removed and surfaces beneath the carpet flooring are thoroughly treated and cleaned with a professional mould treatment (normally a 10% diluted vinegar solution) or suitable air or liquid based alternative (such as HEPA filter vacuum cleaning, air washing, ultrasonic cleaning, steam cleaning or low pressure flushing etc). Subsequently wet wipe all impacted surfaces and allow them to completely dry prior to replacement with new floor coverings. A limited inspection underneath other carpet floor coverings throughout the structure did not identify any further apparent microbial growth, however, as a precautionary measure consideration should be given to the cleaning/replacement of other carpet floor coverings and subsequent remediation measures as detailed above.

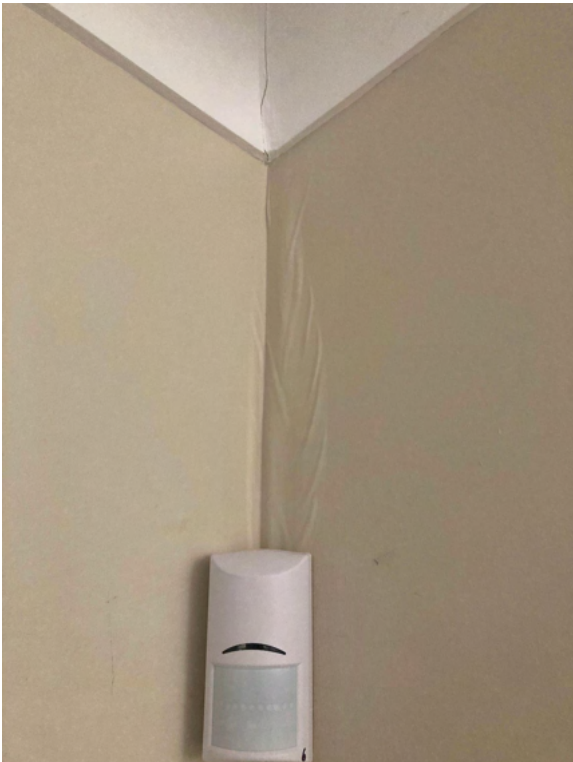
| Photo | Location |
|---|---|
| | <p>Representative photograph of the paint conditions within the south-western 'Office', at the time of the inspection</p> |

- Given the minor paint spalling within the south-western 'Office', consideration should also be given to the removal and/or overpainting of the wall linings with an anti-mould paint

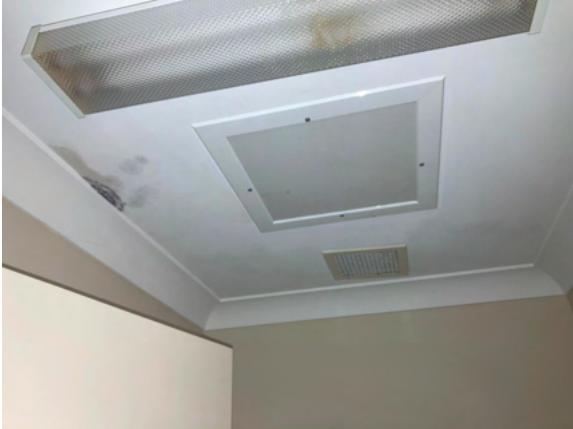
| Sample No. | Location | Bacteria Count (CFU/swab) | Mould Count (CFU/swab) | Yeast Count (CFU/swab) |
|---|---|---|---|---|
| 20-13128/S2 | Youth Centre, internal, 'Male' toilet, ceiling above toilet | <10 | >3000 est. | <10 |

| | <p>Representative photograph of the ceiling above the toilet within the 'Male' toilets, at the time of the inspection</p> |

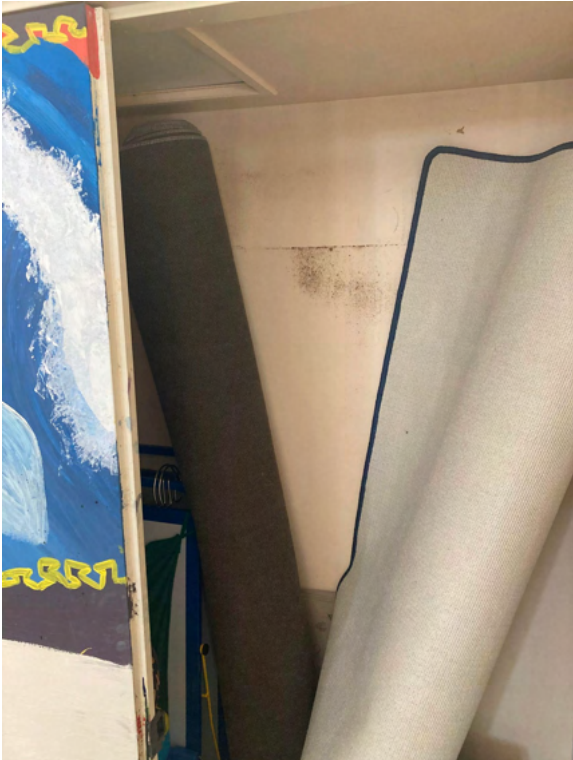
| Sample No. | Location | Bacteria Count (CFU/swab) | Mould Count (CFU/swab) | Yeast Count (CFU/swab) |
|---|---|---|---|---|
| 20-13128/S3 | Youth Centre, internal, 'Meeting Room 3', 2nd most southern cupboard, western wall | 730 | >3000 est. | <10 |

| | <p>Representative photograph of some of the visible microbial growth within one of the cupboards adjoining 'Meeting Room 3', at the time of the inspection</p> |

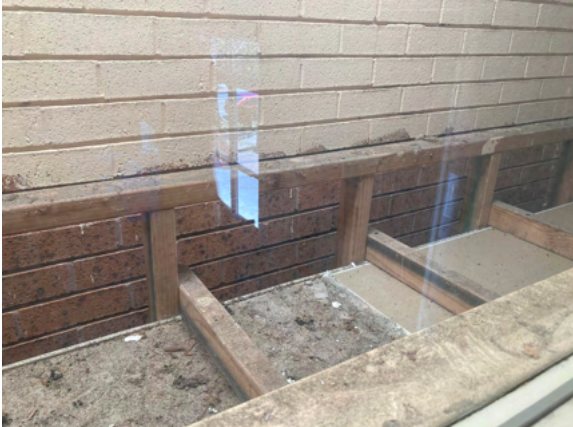
| | <p>Representative photograph of the horizontal surfaces directly above the cupboards adjoining 'Meeting Room 3', at the time of the inspection</p> |

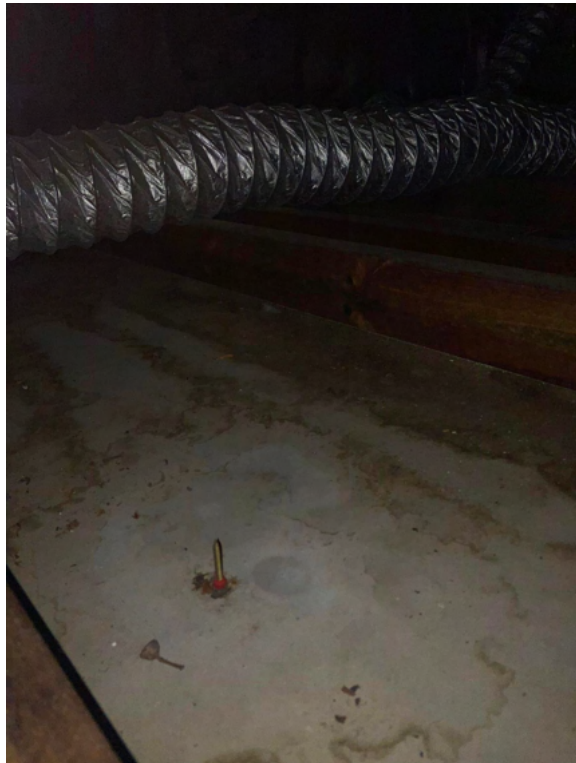
Representative photograph of the horizontal ceiling cavity surfaces within the structure, at the time of the inspection

- Clearsafe recommends that consideration be given to the replacement of all visually microbial impacted ceiling linings throughout the structure subsequent to the identification of the microbial growth/moisture ingress issue. Should this not be an option, all ceiling linings within the structure are to be thoroughly treated and cleaned with a professional mould treatment (normally a 10% diluted vinegar solution) or suitable air or liquid based alternative (such as HEPA filter vacuum cleaning, air washing, ultrasonic cleaning, steam cleaning or low pressure flushing etc). Subsequently wet wipe all impacted surfaces and allow them to completely dry prior. The above also applies to the western cupboards within 'Meeting Room 3' which, excluding visible microbial growth, also appeared structurally damaged.

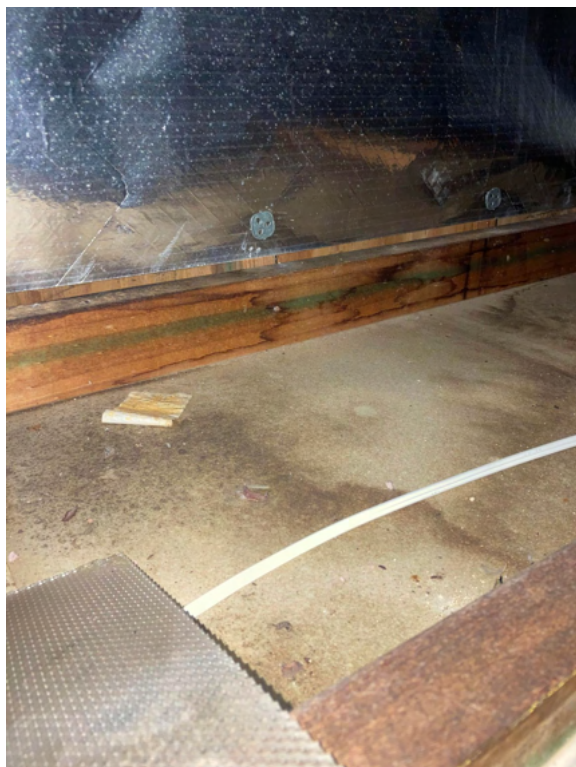
Representative photograph of the horizontal ceiling cavity surfaces within the structure, at the time of the inspection
