# MICROBIAL ASSESSMENT (POST- VENTILATION INSTALLATION) - SECOND INSPECTION

HELENSBURGH  
COMMUNITY CENTRE

26 WALKER STREET  
HELENSBURGH NSW 2508

| Reference: | Revision: | Date of Report: | Prepared By: | Authorised By: |
|---|---|---|---|---|
| 20-13128-02-OH | Revision 0 | 8/11/2021 | Luke Parkins | Michael Fernandez |

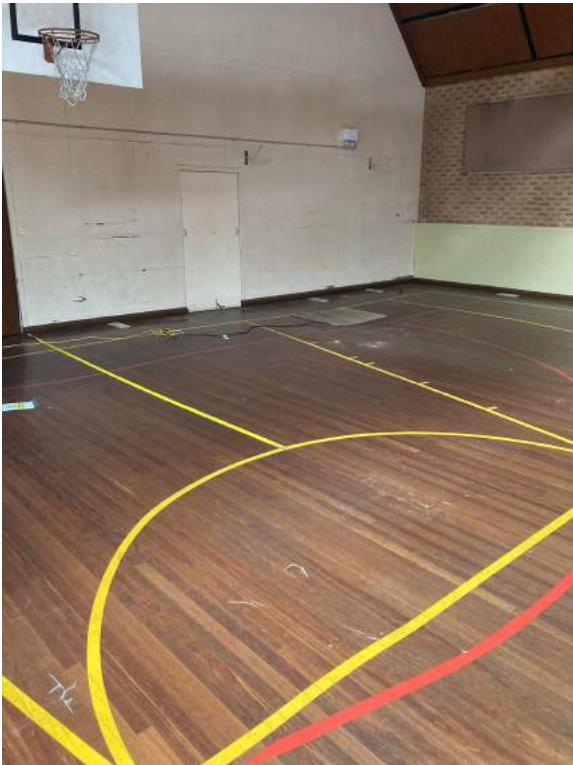
- The condition of the basketball court timber floorboards, viewed from above, had worsened in the western section.
- Several fibrous cement fragments (presumed to be asbestos-containing) were observed within the subfloor at the time of the inspection

| Photo | Location |
|---|---|
| | <p>Representative photograph of the basketball court (western section), at the time of the inspection</p> |

- Clearsafe recommends that the original scope of works for removal is reassessed and extended to include the entirety of the timber hardwood floors due to the uniform nature of damage observed throughout the subfloor during the inspection and presence of mould. It is also suggested that further consideration be undertaken in regards to the replacement of the timber bearers and joists within the subfloor.

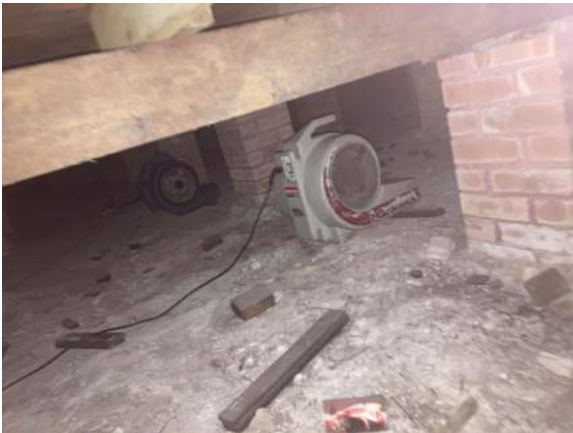
- Visible microbial growth was still observed on the underside of the floorboards and on structural timber joists/bearers within the subfloor
- At the time of the inspection, four (4) kennards hire blower dryers were observed within the subfloor and were in use

| Photo | Location |
|---|---|
| | <p>Representative photograph of the blower dryers within the basketball court subfloor, at the time of the inspection</p> |

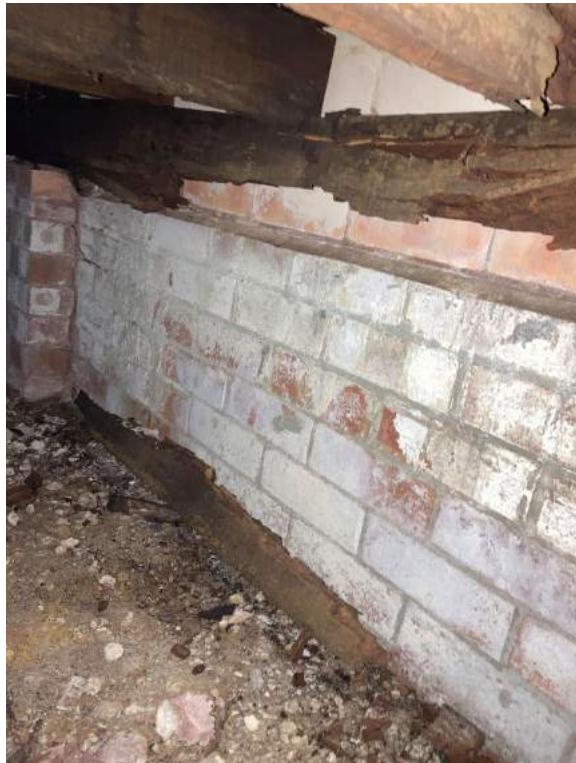
- The ground surfaces and timber joists/bearers within the subfloor were not visibly damp or damp to the touch as opposed to previous assessments.
- A white growth was still observed on the western and northern brick walls of the subfloor

significant rot. Also, the white powdery substance, which the inspecting consultant is of the belief is most likely efflorescence, was still present on the northern and western brick walls of the subfloor and a musty/damp odour was also present within the subfloor at the time of the inspection. Clearsafe recommends appropriate remediation as part of renovation and ongoing maintenance.

Representative photograph of the northern brick wall covered with a white powdery substance, at the time of the inspection

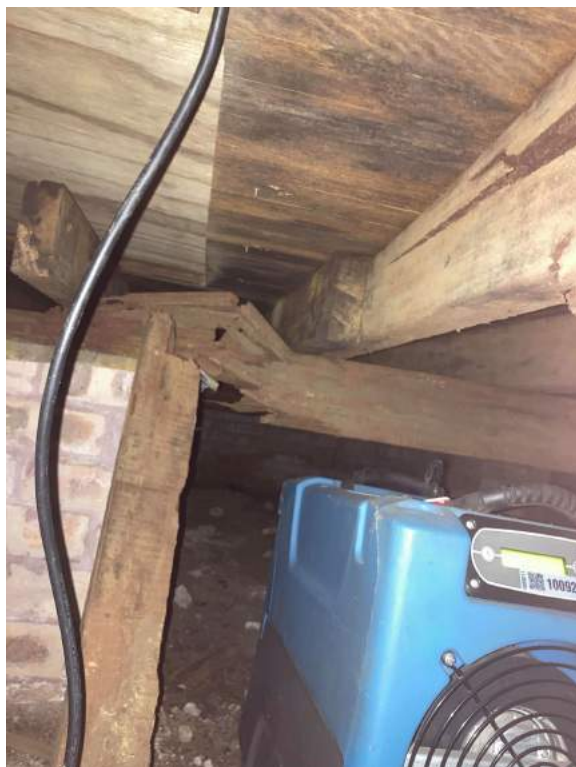
- Several timber joists and timber bearers within the subfloor were completely broken off and/or were significantly damaged, potentially compromising the timber floors structural integrity

Representative photograph of one of the timber bearers within the basketball court subfloor, at the time of the inspection

- Given the compromised structural integrity of the timber bearers and joists within the subfloor, Clearsafe recommends that access is restricted/limited.
