# MICROBIAL ASSESSMENT

## HELENSBURGH COMMUNITY CENTRE

26 WALKER STREET  
HELENSBURGH NSW 2508

| Reference: | Revision: | Date of Report: | Prepared By: | Authorised By: |
|---|---|---|---|---|
| 20-12361-01-OH | Revision 0 | 8/12/2020 | Luke Parkins | Michael Fernandez |

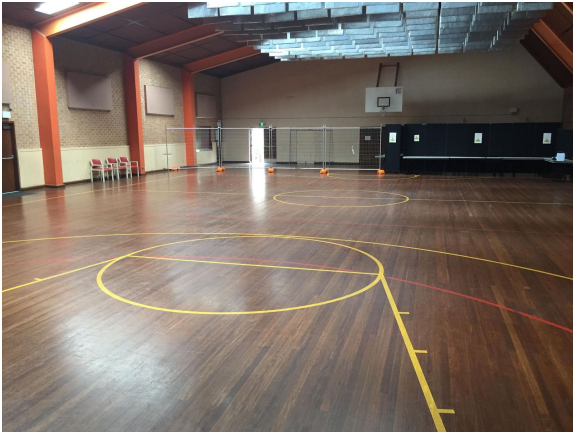
| Photo | Location |
|---|---|
| | <p>Representative photograph of the basketball court (including the western 'restricted' section)</p> |

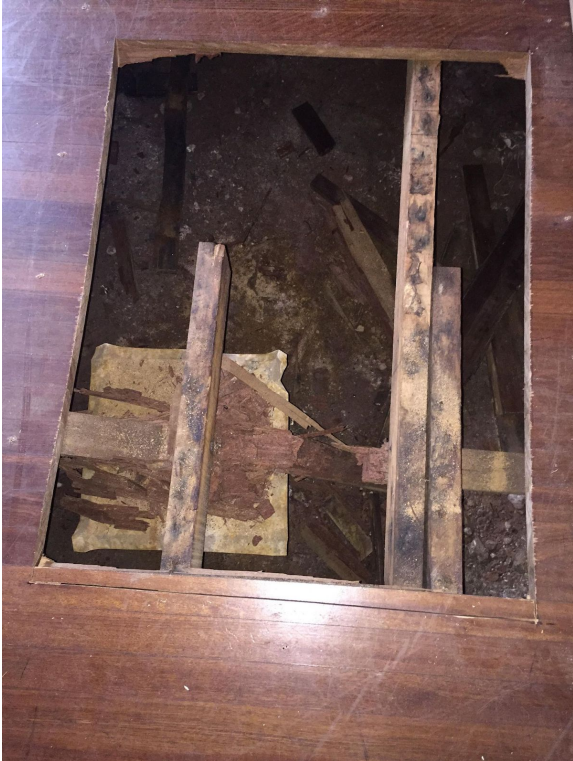
| Photo | Location |
|---|---|
| | <p>Representative photograph of the western access point into the subfloor</p> |

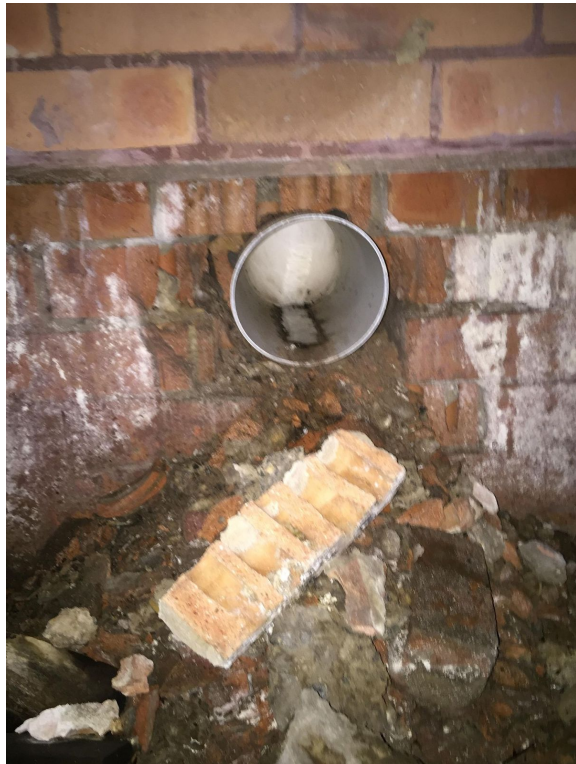
- Pipes were observed along the western brick wall of the subfloor that extend from the outside of the building to within the subfloor (believed to be the source of the water ingress)

Representative photograph of one of the pipes along the western wall of the subfloor

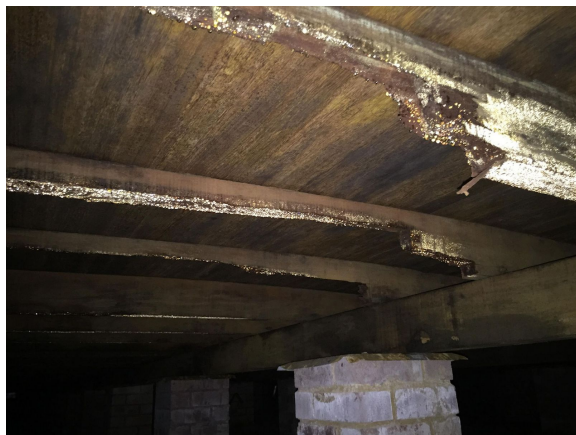
- The ground surfaces and timber joists/bearers within the subfloor were visibly damp in multiple locations, the timber bearers/joists were dripping with water at the time of the inspection

Representative photograph of several floor timber joists that have partially broken and are coated with moisture

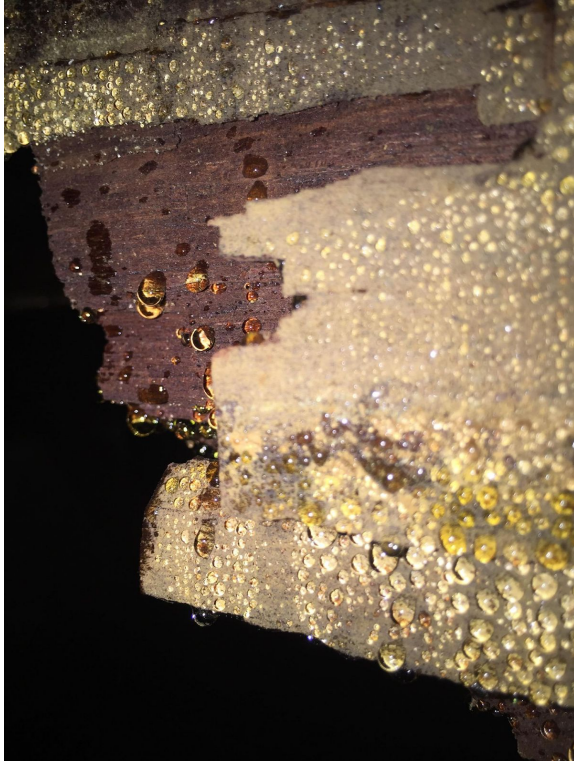
Representative photograph of one (of many) of the floor timber joists

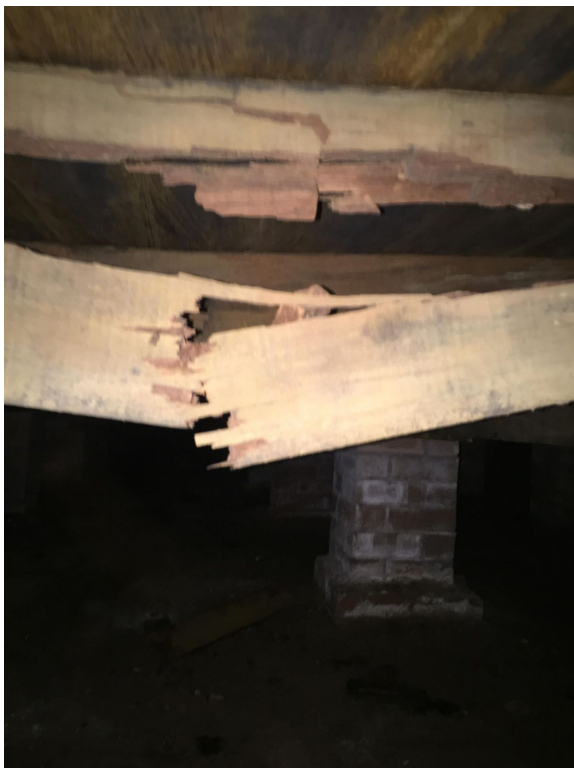
- A white growth was observed on the western and northern brick walls of the subfloor, both of which were also considerably wet
- Several timber joists and timber bearers within the subfloor had completely broken off and/or were significantly damaged compromising the timber floors structural integrity

Representative photograph of a broken floor timber joist within the subfloor

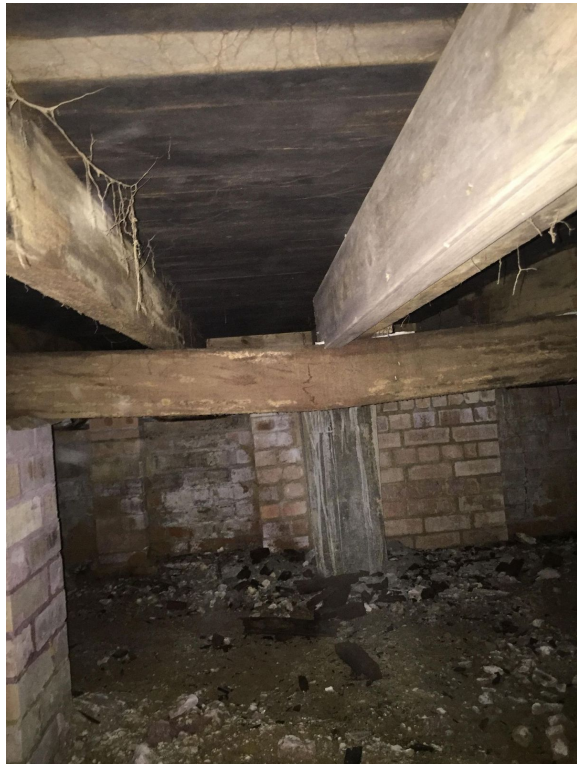
Representative photograph of a fractured floor timber bearer

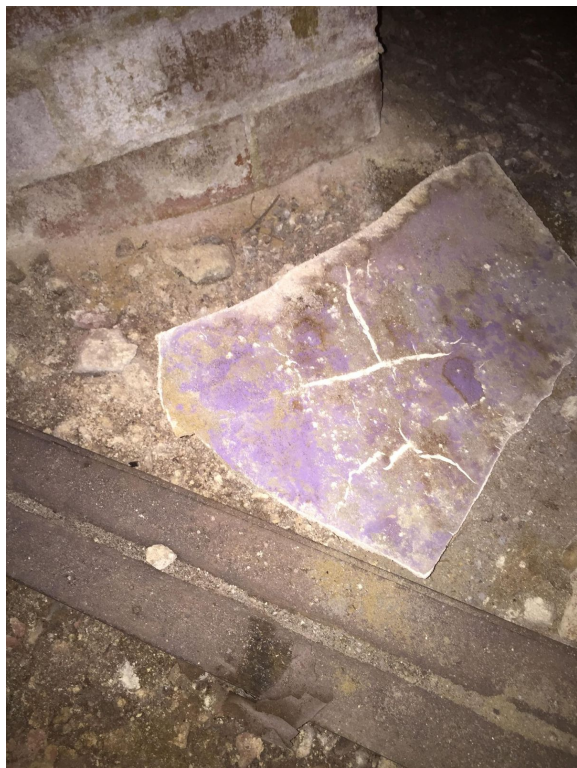
- Viewed from above, several spots on the basketball court were visibly uneven
- Several fibrous cement fragments (presumed to be asbestos-containing) were found within the subfloor at the time of the inspection

Representative photograph of remnant fibrous cement sheeting within the subfloor

- 
- Throughout the course of the inspection fibrous cement fragments suspected of containing asbestos were observed sporadically scattered throughout the subfloor ground surfaces. Clearsafe recommends an emu pick of the ground surfaces, with consideration given to conducting a scrape of 50-100mm of soils within the subfloor due to the incredibly damp and most likely microbial impacted nature of the soils. If any material suspected of containing asbestos is identified in the future (outside of that already identified), stop work immediately, restrict access to the impacted area and contact Clearsafe for further advice.

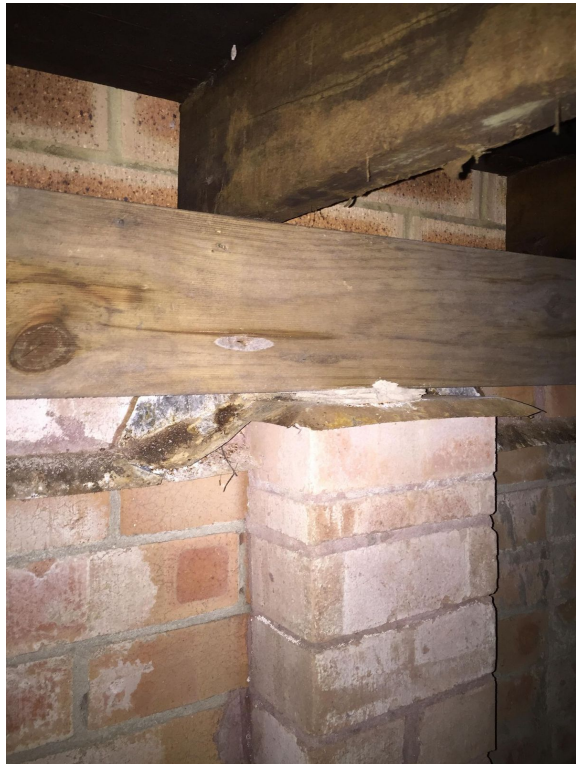
Representative photograph of fibrous cement packers supporting the timber bearers

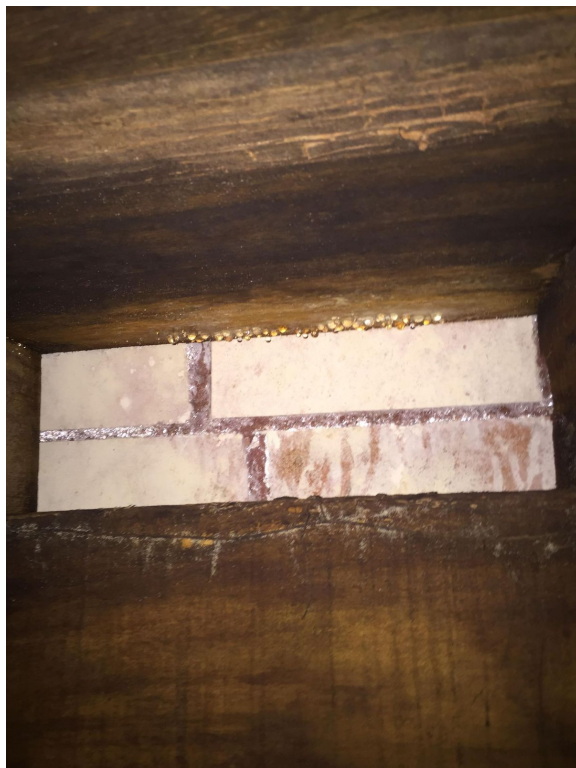
Representative photograph of the northern brick wall within the subfloor

- Clearsafe is of the understanding that the western wall of the basketball court is also being replaced and new ventilation is being installed, it is recommended that the northern wall of the basketball court is also removed and replaced and adequate ventilation installed to allow for air flow within the subfloor.

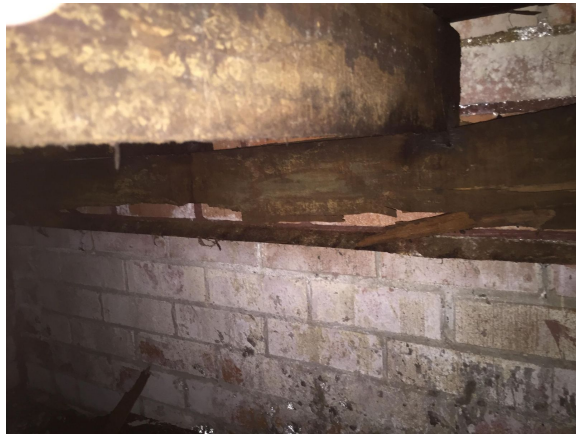
Representative photograph of a floor timber bearer immediately adjacent the northern brick wall
