# MICROBIAL ASSESSMENT

## HELENSBURGH COMMUNITY CENTRE

26 WALKER STREET  
HELENSBURGH NSW 2508

| Reference: | Revision: | Date of Report: | Prepared By: | Authorised By: |
|---|---|---|---|---|
| 20-12361-02-OH | Revision 0 | 9/3/2021 | Luke Parkins | Michael Fernandez |

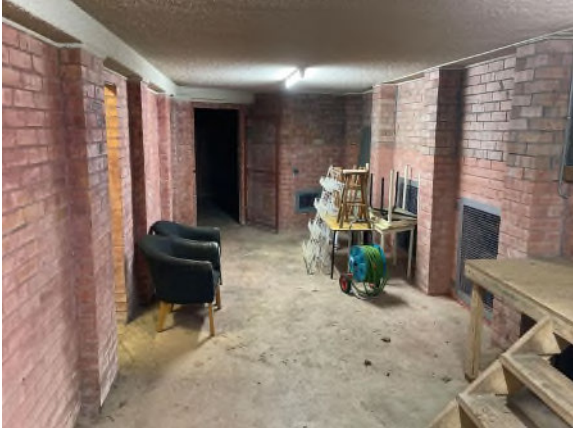
- A mouldy/musty odour was present within the basement at the time of the inspection.
- The basement area consists of three (3) open rooms (one of which was padlocked and unable to be accessed and appears to be used for storage) and a corridor connecting the three rooms.

- All walls within the basement are brick, the floors are concrete and all ceiling linings are concrete with the exception of the ceiling beneath the stage which is vermiculite.

| Photo | Location |
|---|---|
| | <p>Representative photograph of the basement (room beneath the stage), at the time of the inspection</p> |

- Clearsafe recommends that all surfaces within the basement area (flooring, walls and ceilings) are thoroughly treated and cleaned with a professional mould treatment (normally a 10% diluted vinegar solution) or suitable air or liquid based alternative (such as HEPA filter vacuum cleaning, air washing, ultrasonic cleaning, steam cleaning or low pressure flushing etc). Subsequently wet wipe all impacted surfaces and allow them to completely dry prior

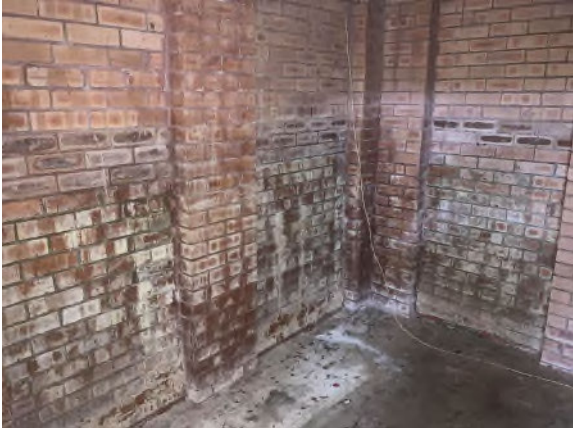
- A white growth was observed within the southern room of the basement that was primarily concentrated along the eastern and southern walls and extended from the concrete flooring to approximately halfway up the wall.

| Photo | Location |
|---|---|
| | <p>Representative photograph of the eastern and southern walls of the southern room of the basement, at the time of the inspection</p> |

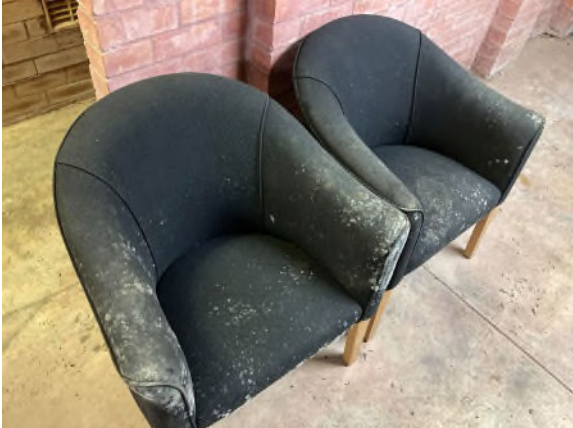
- Furnishings within the two (2) accessible rooms consisted of several armchairs which appeared to be mould impacted and tables within the room beneath the stage and various pipes/cables and a shelving unit within the southern room.

| Photo | Location |
|---|---|
| | <p>Representative photograph of the armchairs within the basement (room beneath the stage), at the time of the inspection</p> |

- At the time of the inspection, two green armchairs were located within the basement (beneath the stage) both of which displayed visible evidence of mould growth, one of which was sampled. Results displayed significantly high microbial contamination, as such, and given the porous nature of the materials, it is recommended that the armchairs are completely disposed of. Hard furnishings with no apparent visible growth were also identified within the same room, as a precautionary measure Clearsafe recommends that these furnishings are thoroughly cleaned as per processes referred to above.

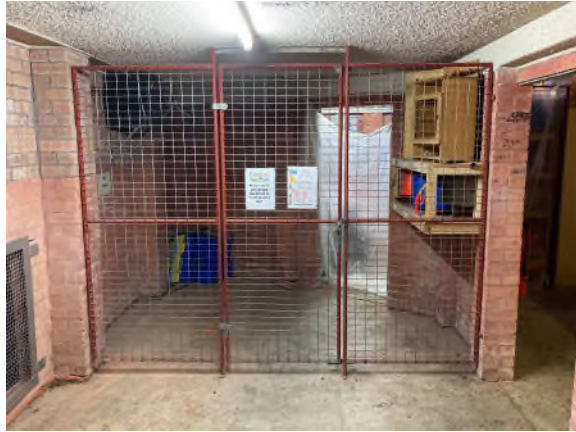
Representative photograph of the padlocked room within the basement, at the time of the inspection

- At the time of the inspection the northern room of the basement was padlocked, various miscellaneous items could be observed from outside the gate, however, it was difficult to accurately determine any microbial contamination. It is recommended that once access allows, this area is thoroughly inspected, including each of the

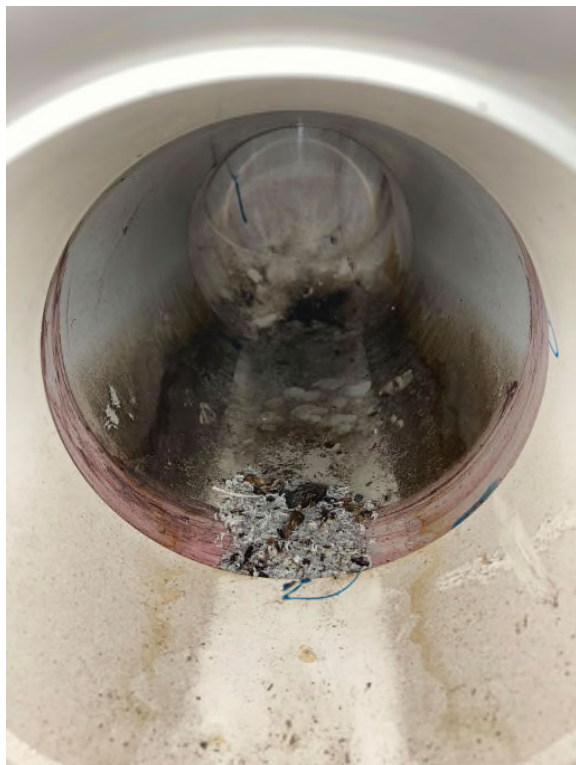
- Two (2) L-shaped pipes were observed along the southern wall of the southern room that internally appeared to be covered with mould and stagnant water. These pipes

terminated at the brick wall surface and directly beneath on the concrete flooring was visually observed water markings/staining.

Representative photograph of one of the L-shaped pipes within the southern room of the basement, at the time of the inspection

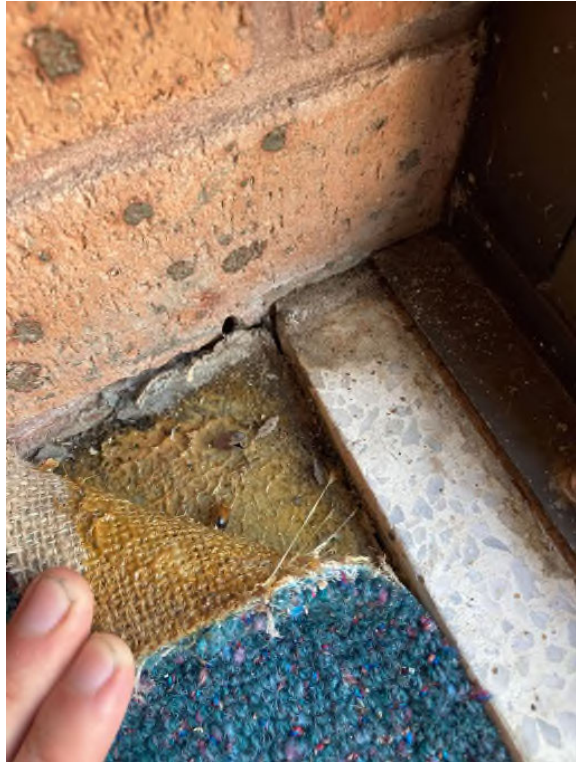
- The meeting rooms consist of carpet flooring, brick walls and a cork-like material for the ceiling.
- What appeared to be visible mould was observed underneath the carpet flooring immediately adjacent the southern doors of both of the meeting rooms, at the time of the inspection.
- There was no mouldy/musty odour present within these areas, at the time of the inspection.

Representative photograph of the flooring beneath the carpet within Meeting Room 2, at the time of the inspection

- It is recommended that the carpet within the meeting rooms is removed and surfaces beneath the carpet flooring are thoroughly treated and cleaned with a professional mould treatment (normally a 10% diluted vinegar solution) or suitable air or liquid based alternative (such as HEPA filter vacuum cleaning, air washing, ultrasonic cleaning, steam cleaning or low pressure flushing etc). Subsequently wet wipe all impacted surfaces and allow them to completely dry prior to replacement with new flooring. Without complete removal of all carpet flooring within the meeting rooms and adjoining corridor/rooms it is difficult to accurately determine the extent of microbial growth beneath the carpet flooring. As such, it is recommended that following removal of the meeting rooms carpet flooring that adjoining areas be assessed and replaced accordingly.

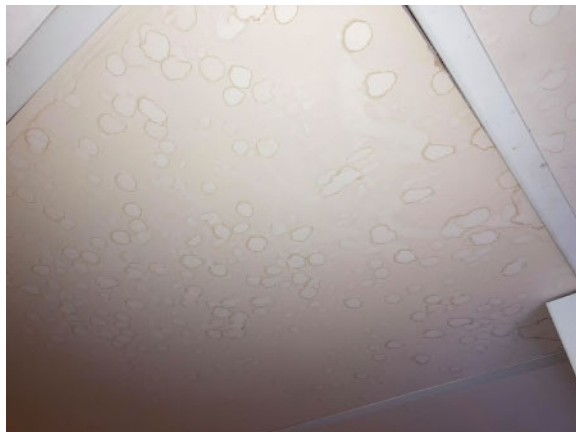
- The male and female bathrooms consist of tiled flooring, rendered concrete walls, and ceiling panels.
- There was no mouldy/musty odour present within these areas, at the time of the inspection.
- No visible mould was observed on any of the wall, ceiling or flooring surfaces within these areas, at the time of the inspection. However, ceiling panels within the washroom section of both of the bathrooms did exhibit visual evidence of water staining.

Representative photograph of a ceiling panel within the female bathroom, at the time of the inspection
